Unexpected Problems with Kettle Reboiler Circuit

Fractionation Research, Inc (FRI)

June 19, 2019

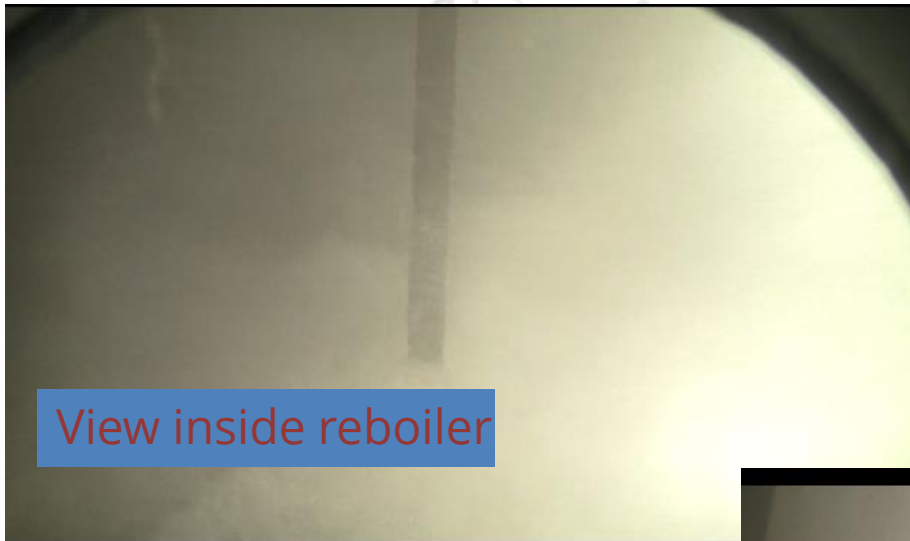
View inside reboiler

C6/C7 System
- 2.0 bara (1.62 bara)
- 2.0 m/s (1.0 m/s)
- Heat Flux: 36 kW/m² (9.0 cal/cm²·s)

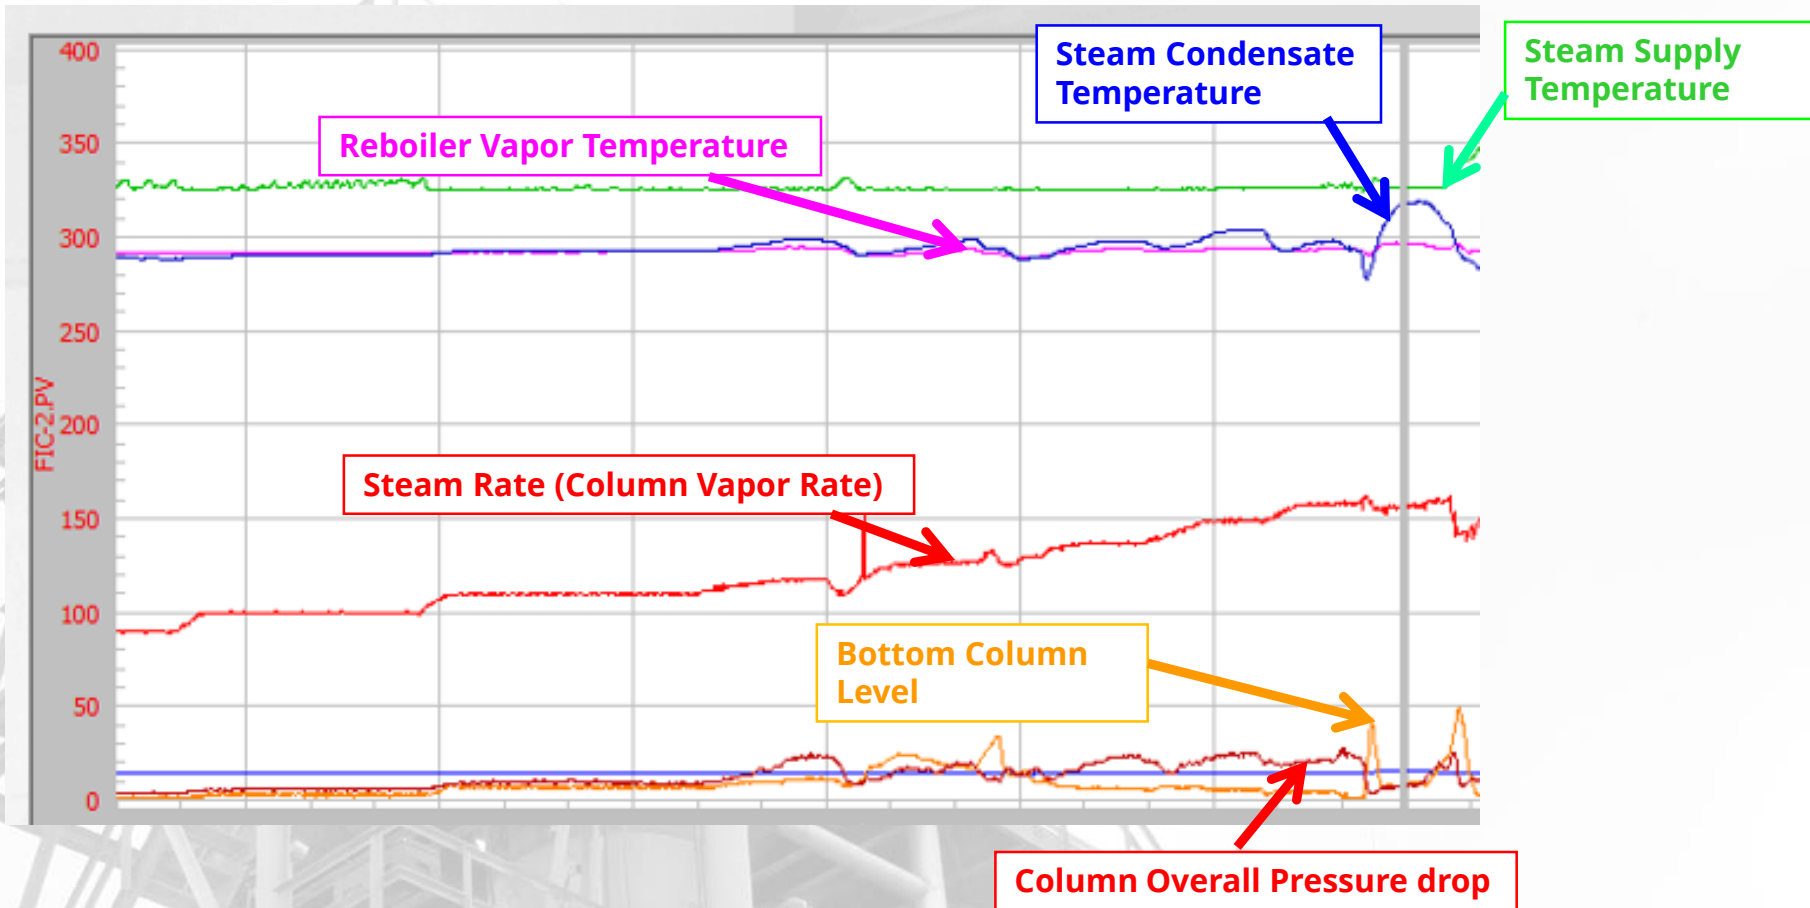
Operation Trends

- Symptom
 - While increasing the reboiler duty, the column behaved like that it was flooded, but at a vapor rate much less than expected
 - The reboiler duty at this operating pressure was much lower than design duty

- Level in bottom of column abnormally high
- Bottom half of column higher than top half pressure drop
- Atypical to normal flood behavior; much less flooding vapor rate than expected
- Steam condensate temperature erratic
- Spikes in bottom column level

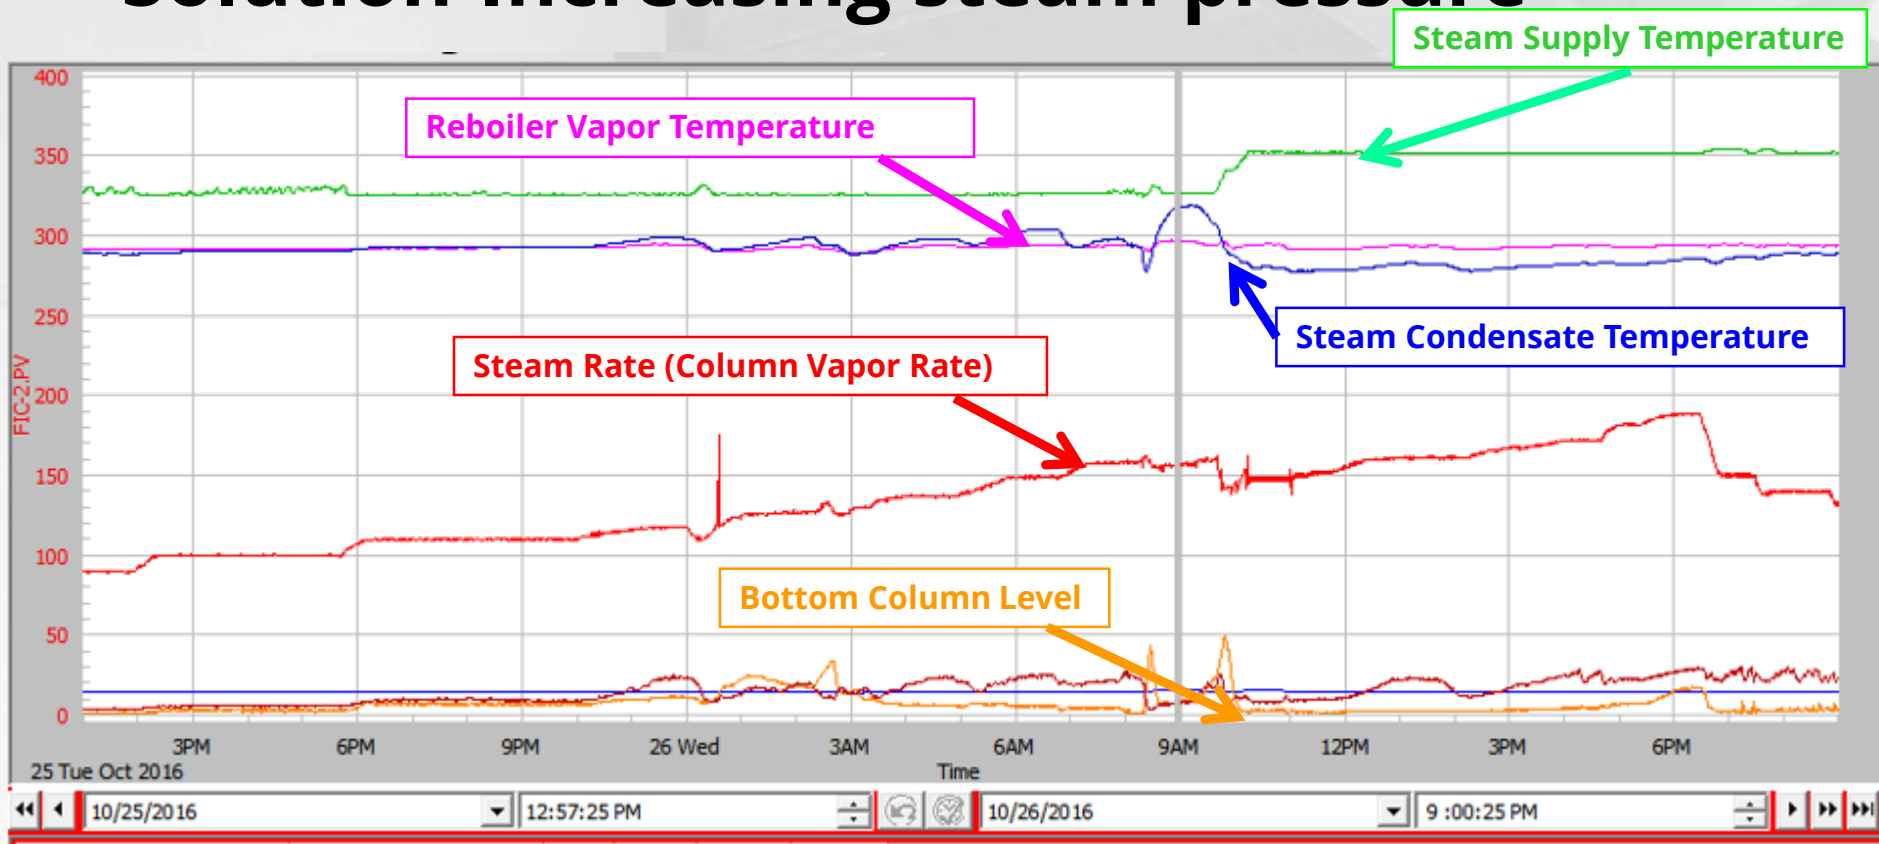
Solution-Increasing steam pressure

In this case, capacity increased by ~19% by operating with larger temperature driving force in reboiler

- Instead of reducing the operating pressure, increased the steam temperature

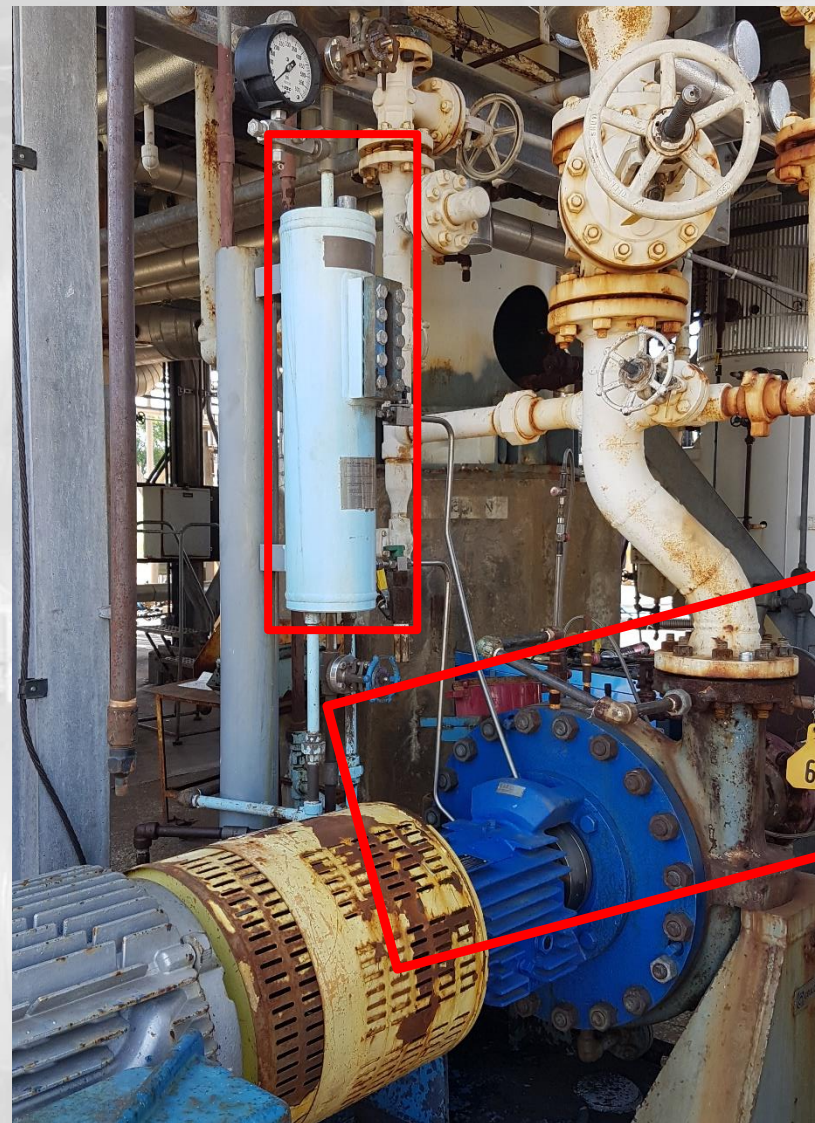
- Problems:
 - Experienced cavitation type of problem with the bottom pump, during iC4/nC4 operations at 27 bara (400psia)
 - Caused pump mechanical seal failure
- Symptoms:
 - Very loud pump noise
 - C4's spilled out of the seal pot vent
