Unexpected Problems with Kettle Reboiler Circuit

Fractionation Research, Inc (FRI)

June 19, 2019

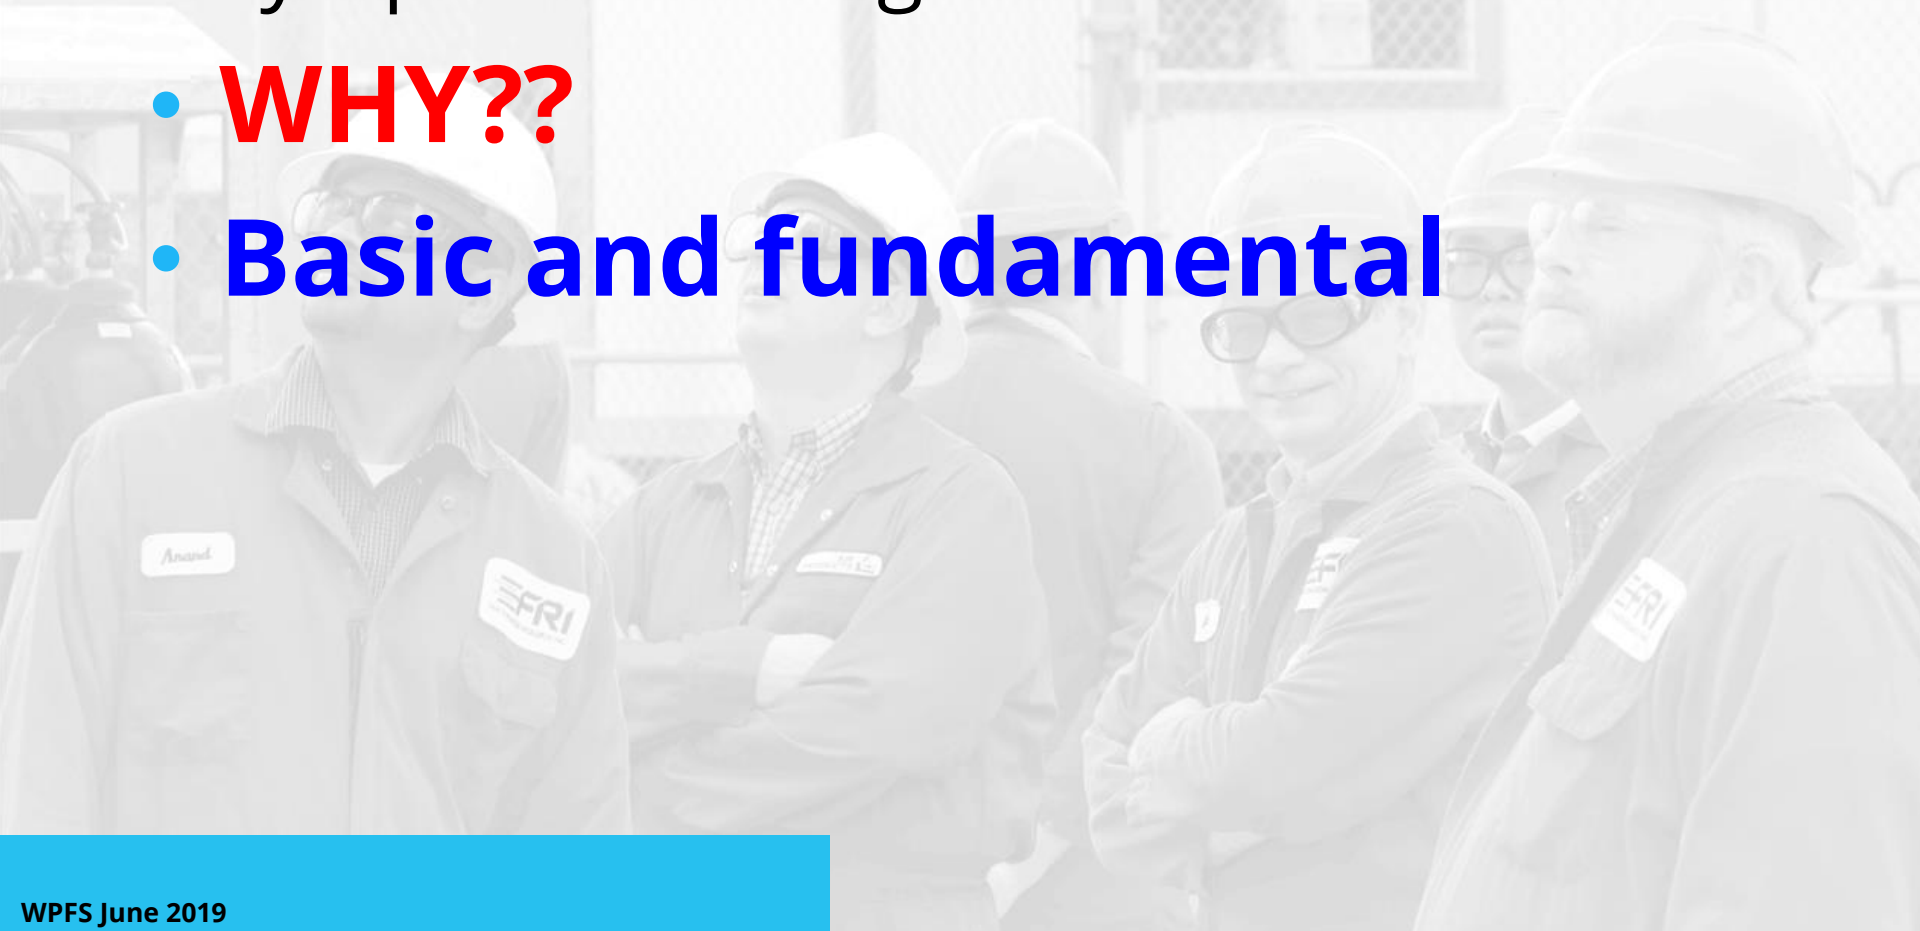
Investigation & Troubleshooting

- When the column operating pressure was reduced to certain value, all symptoms were gone
- **WHY??**
- **Basic and fundamental**

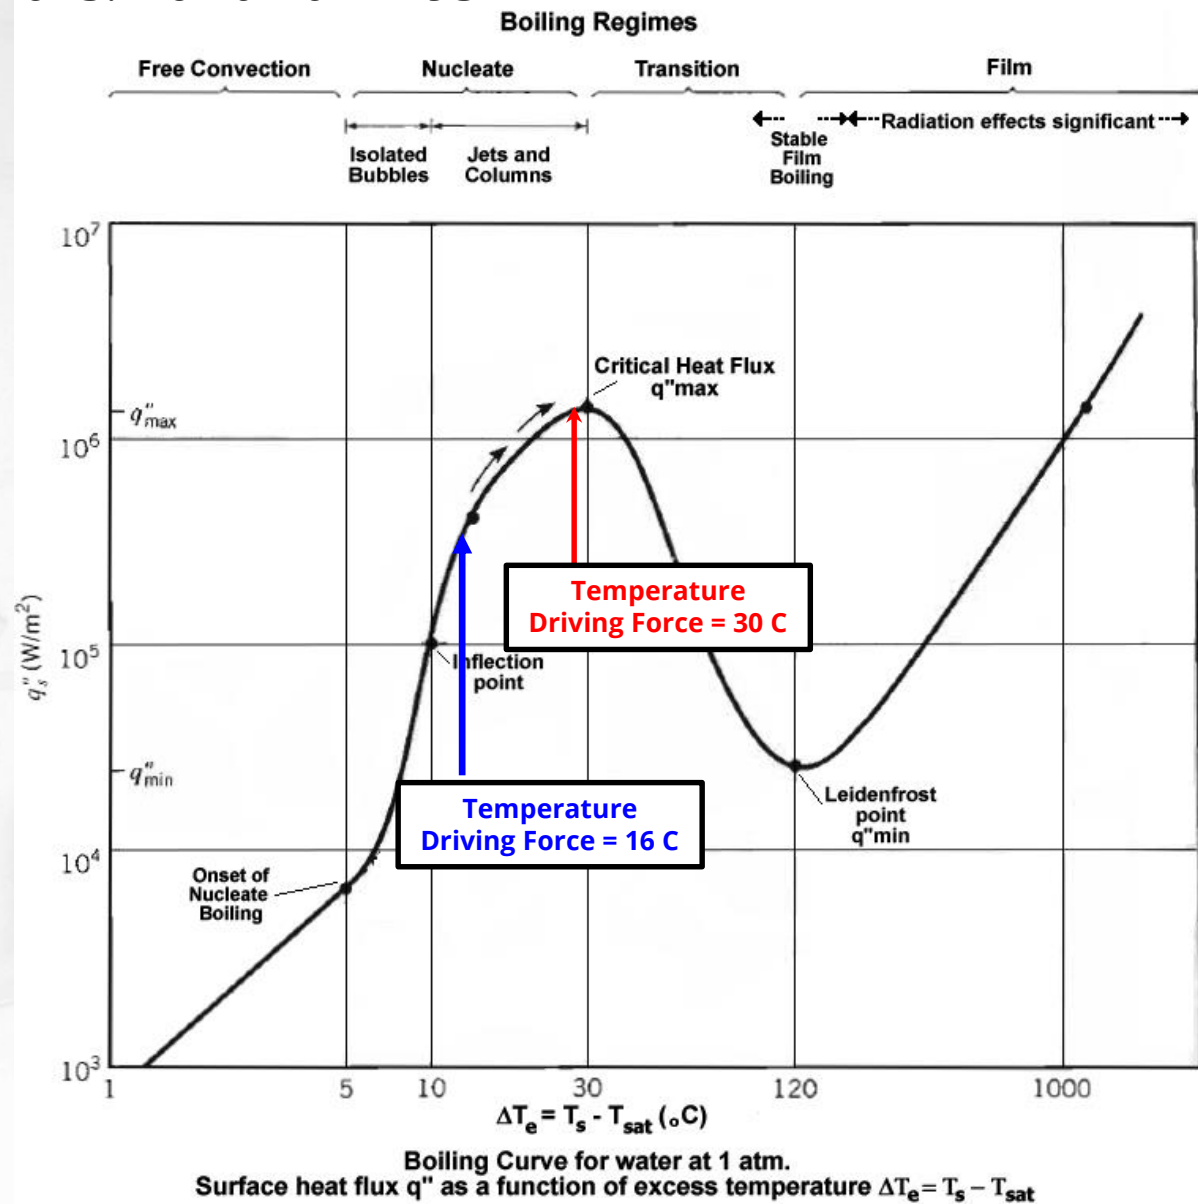
Boiling Regimes

Graph courtesy of S. Nukiyama in 1934

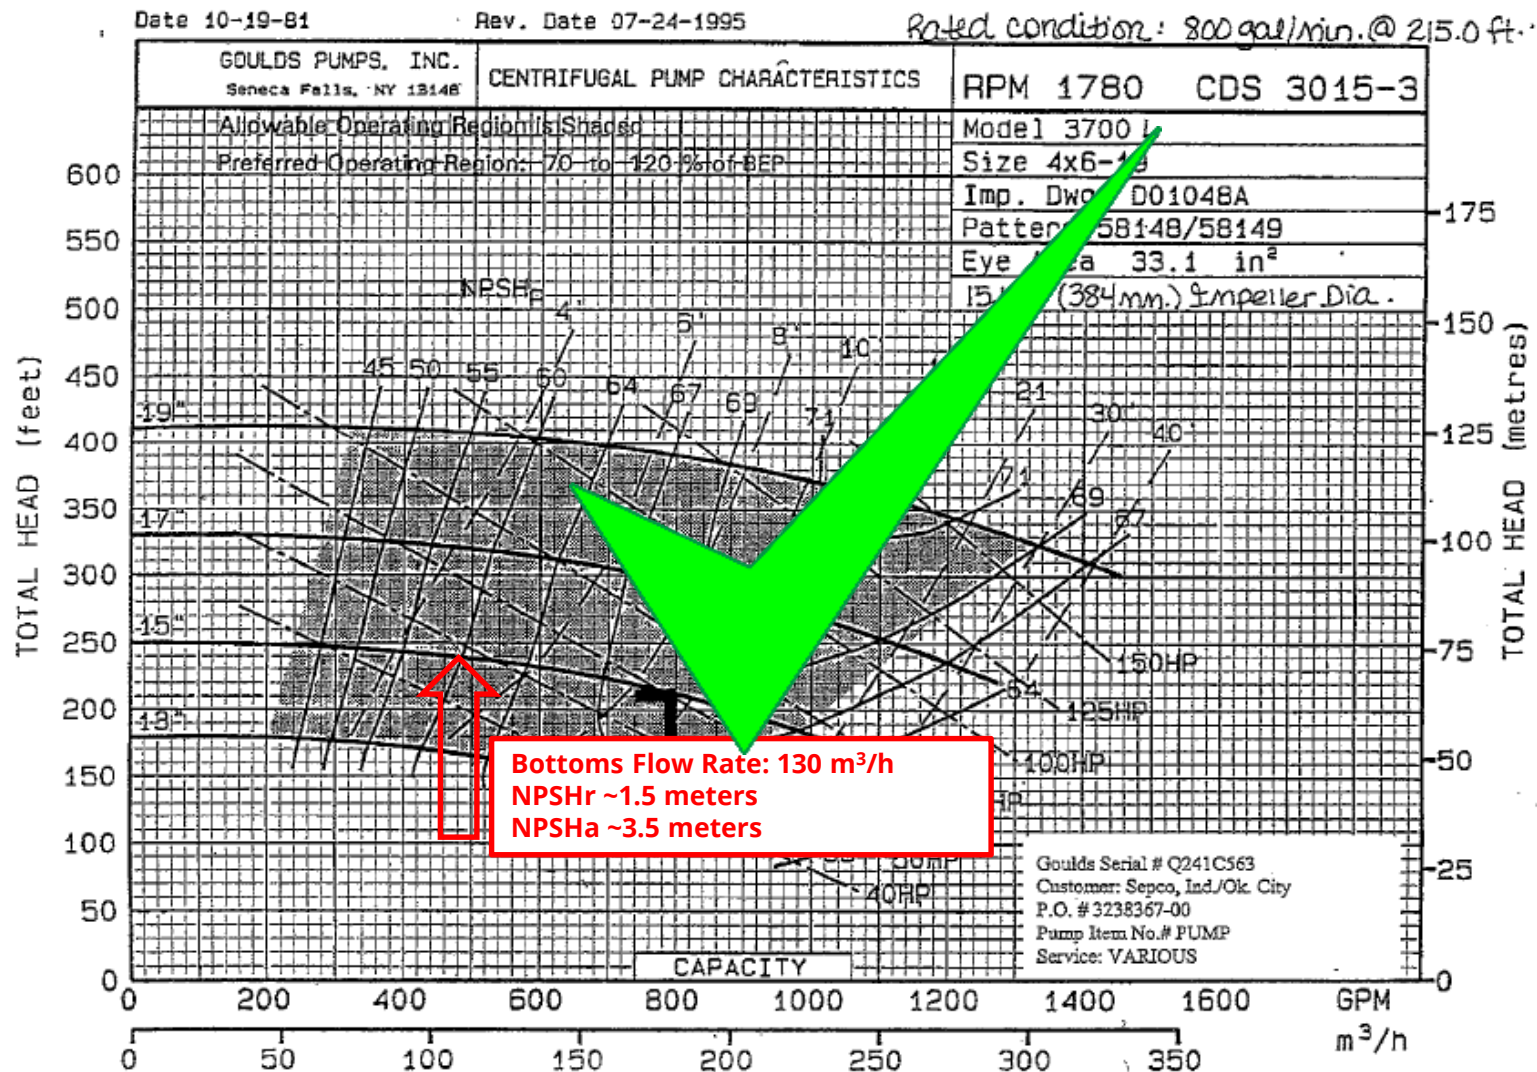
Pump Curve

- Cavitation?
 - NPSHr (Net Positive Suction Head required) by the pump
 - The NPSHa should always be one to two feet (0.3 to 0.6 m) above the NPSHr of the pump to prevent cavitation

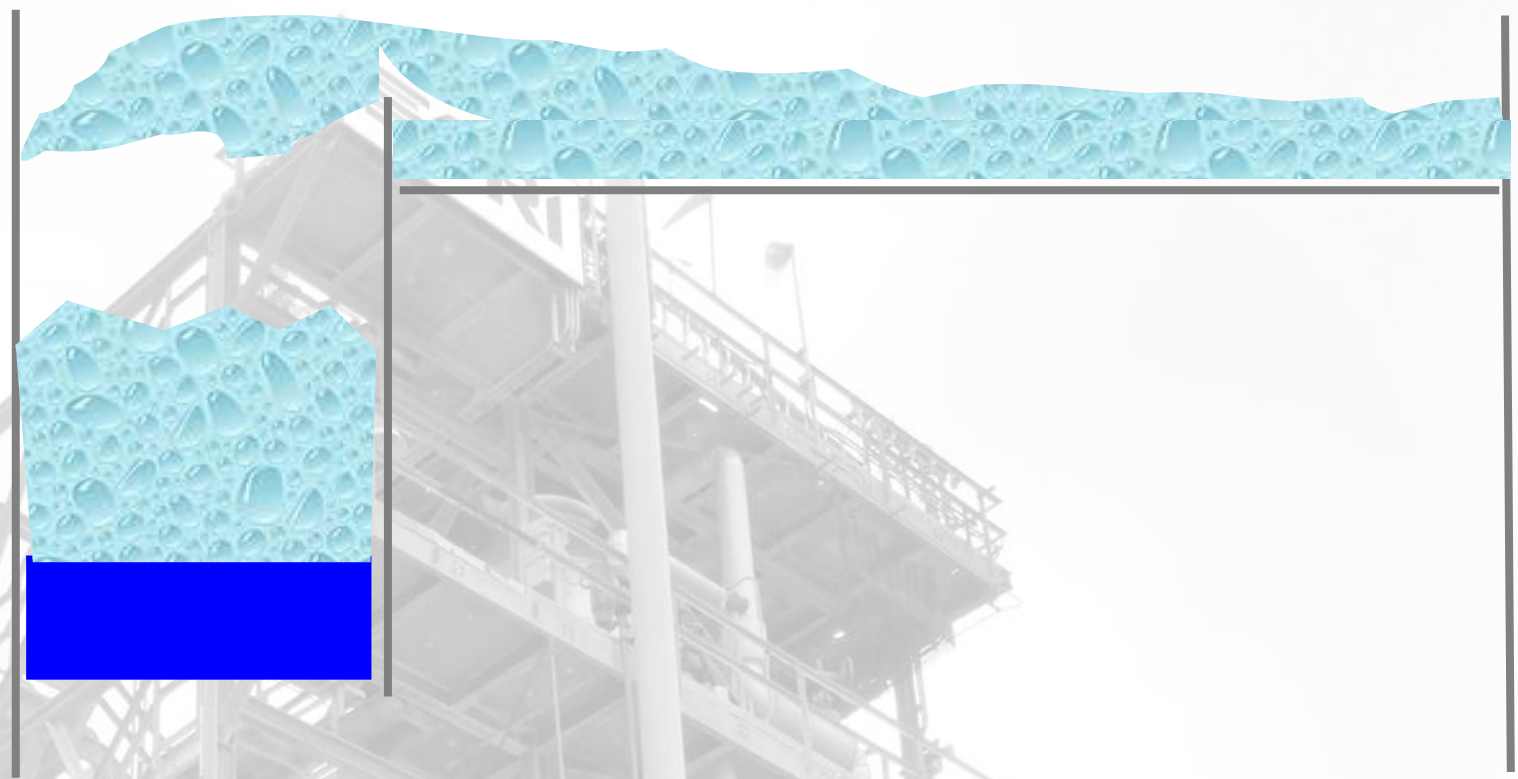
Downcomer Choke Flood

- Cavitation in the bottom pump was probably caused by the similar mechanism as what caused tray downcomer choking
- Or the cavitation was caused by vapor entrainment

- Operating the kettle reboiler away from the conditions at which vapor entrainment may occur by reducing the reboiler circulation rate and vapor loading
- Increasing the size of the outlet of the reboiler bottom flow
